FINAL REPORT AUGUST 1990

REPORT NO. EVT 14-90

RAIL IMPACT TEST OF ROTARY TOWED SWEEPER

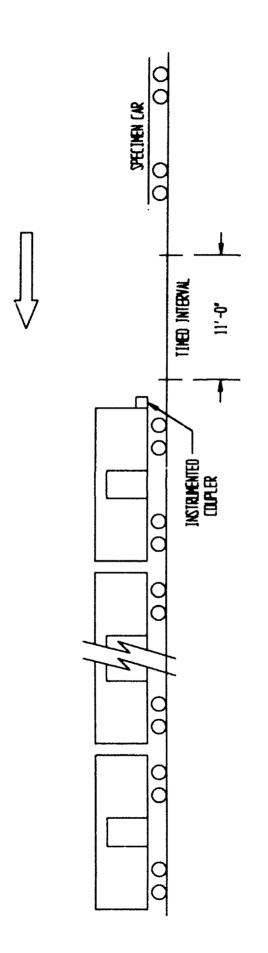
- 1. Test Load (specimen). The rotary towed sweeper test load was prepared for rail testing IAW manufacturer's instructions. The sweeper was then loaded onto the railroad flatcar and, using the blocking and bracing methods specified in the outloading procedures in figures 1 and 2, secured to the flatcar. The railcar used in the test was inspected to ensure its adequacy for transportation.

- (1) CHOCK BLOCK (6 REQUIRED). 24" LONG BY 6" WIDE BY 8" HIGH. LOCATE 45 DEGREE END OF BLOCK AGAINST WHEEL. NAIL THROUGH HEEL OF BLOCK W/3-40d NAILS AND 2-60d NAILS. NAIL EACH SIDE TO THE CAR FLOOR W/2-40d NAILS.

- 2 ANTI-CHAFING WATER-PROOF PAPER OF A SUFFICIENT SIZE TO POSITION UNDER AND EXTEND 2" ABOVE PIECE MARKED (3).
- (3) RUBBING STRIP, 2" BY 6" BY 30" (4 REQUIRED). POSITION ON EDGE AND NAIL TO LOWER PIECE MARKED 4 W/1-12d NAIL EVERY 8".

- 4 SIDE BLOCKING, 2" BY 4" BY 30" (TRIPLED) (4 REQUIRED). NAIL FIRST PIECE TO CAR FLOOR W/1-20d NAILS, EVERY 8". NAIL EACH ADDITIONAL PIECE IN THE SAME MANNER.

- (5) THIMBLE, STANDARD, SIZE 3/8" (8 REQUIRED). USE ONE PER STAKE POCKET AND ONE PER LADING TIE-DOWN AND/OR LIFTING DEVICE.
- 6 FRONT TIEDOWN, 3/8" DIAMETER STEEL WIRE ROPE, 24'-0" LONG (2 REQUIRED). INSTALL THE CABLE ANGULARLY, AS SHOWN, TO FORM A COMPLETE LOOP FROM THE STAKE POCKET ON THE CAR TO THE LADING TIEDOWN DEVICE AND BACK TO THE STAKE POCKET.

- (7) CLIP, SIZE 3/8" (16 REQUIRED). APPLY FOUR CLIPS PER CABLE JOINT.
- 8 REAR TIE-DOWN, 3/8" DIAMETER STEEL WIRE ROPE, 18'-0" LONG. SECURE IN THE SAME MANNER AS PIECE MARKED (6).

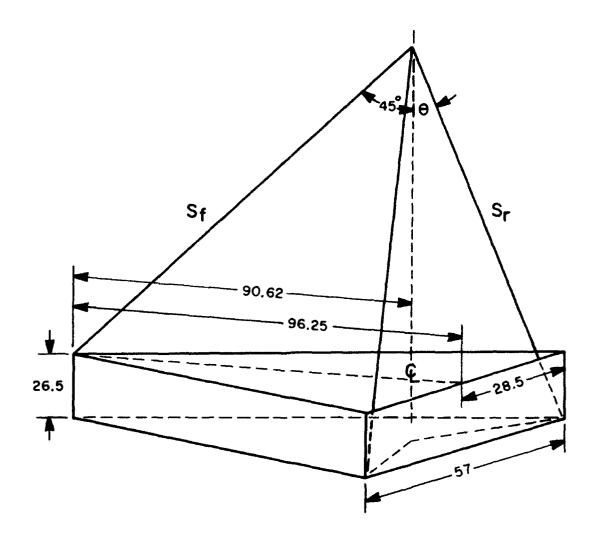
REAR LIFT PROVISION

DESIGN LOADS

$$V_r = (90.62) (2.140 LBS.)$$
 = 2,024.24 POUNDS

- 5. VERTICAL FORCE IS SHARED BY TWO PROVISIONS: 2,024.24/2 = 1,012.12 POUNDS.
- 6. RESULTANT FORCE COMPONENT AT 45 DEGREES:

- 7. DESIGN LOAD = (1,431.35)(3.2) = 4,580.3 POUNDS.
- 8. EACH REAR PROVISION SHOULD BE PULLED AT 45 DEGREES AND HELD AT 4,580 POUNDS FOR 90 SECONDS.

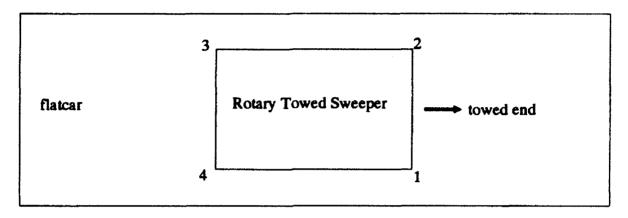
Tiedown Cable Tension

The diagram shows a layout of the rotary towed sweeper positioned on a flatcar. Nos. 1 - 4 label each tiedown cable that secured the sweeper to the flatcar. Cable tension was measured after each impact and is recorded below.

Impact 0 is the tension on each cable before rail impacting the rotary towed sweeper. Impacts nos. 1 - 3 were in the towed direction, impact no. 4 was in the reverse direction. The decrease in cable tension with successive impacts was attributed to the cables cutting into the wooden flatcar deck from the jerk occurring with each impact.

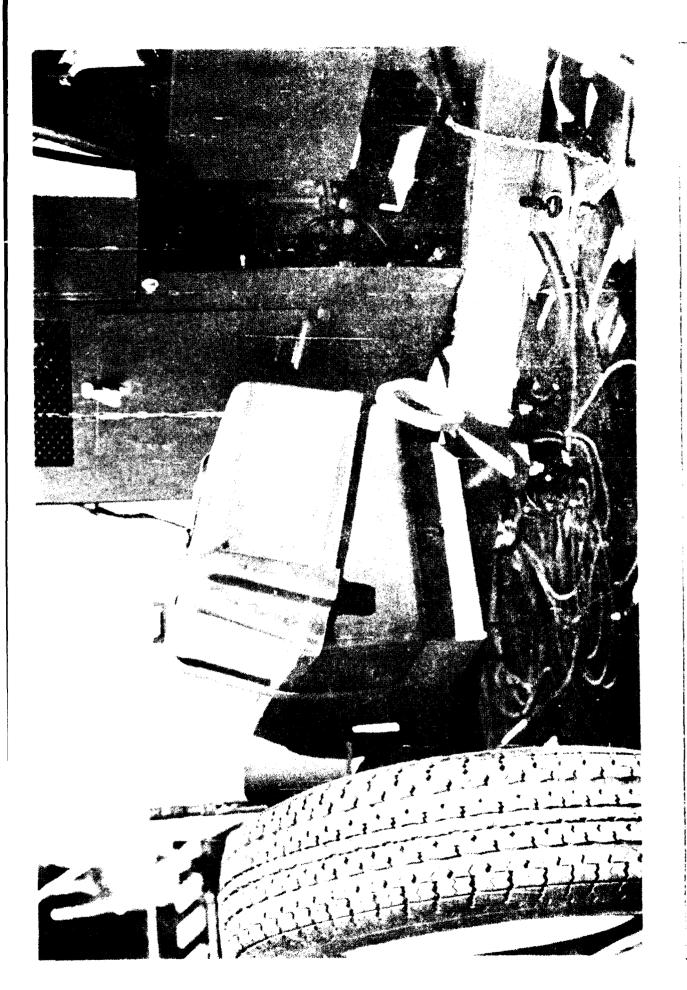
Photo No. A0317-SPN-90-328-3905. This photo shows the rotary towed sweeper battery case after a rail impact Tightening the battery case cover strap did not improve holding the cover in its operating position.

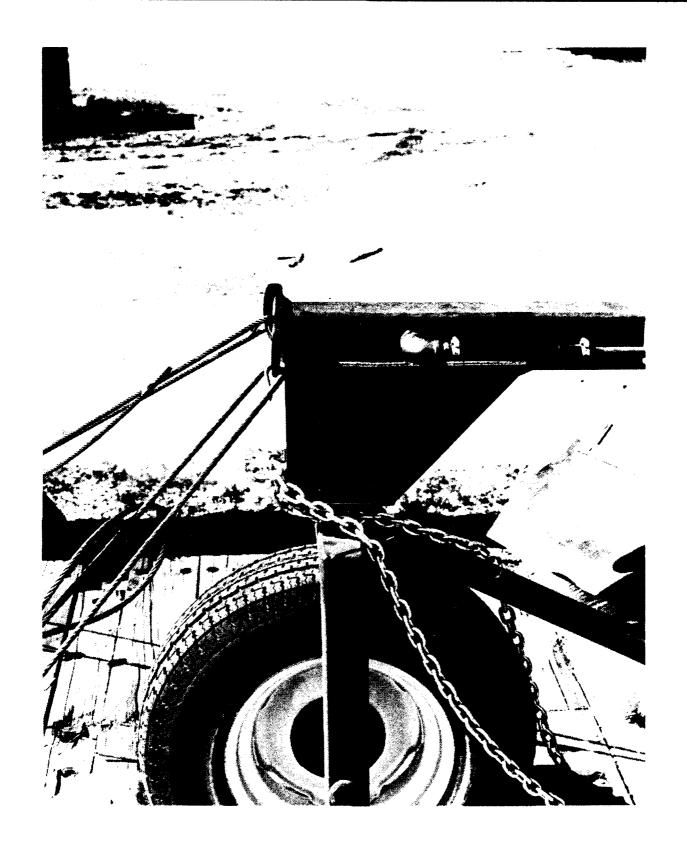
D. <u>CONCLUSION</u>. The rotary towed sweeper was tested twice. The first rail impact test resulted in a deformed tiedown provision. For the second test with a redesigned tiedown provision, the rotary towed sweeper passed the MIL-STD-810D rail impact test and the test requirements of MIL-STD-209G.

The rotary towed sweeper failed rail impact testing. The rear tiedown provision deformed. It was recommended that the tiedown provision be strengthened.

Photo No. A0317-SPN-90-328-3906. This photo shows the forward tiedown provisions on the towed end of the rotary towed sweeper. Note the deformation of the tiedown. Initial deformation occurred during equipment tie-down. Additional deformation occurred during rail impact testing.

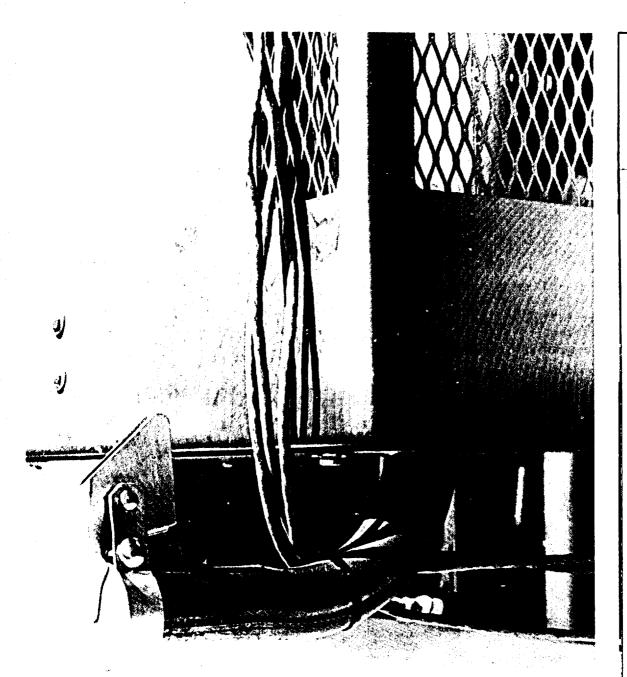
Photo No. A0317-SPN-90-328-3910. This photo shows the rear tiedown fitting on the rotary towed sweeper. Wire cable is used to secure the sweeper to the railcar. Note the wheel blocking.

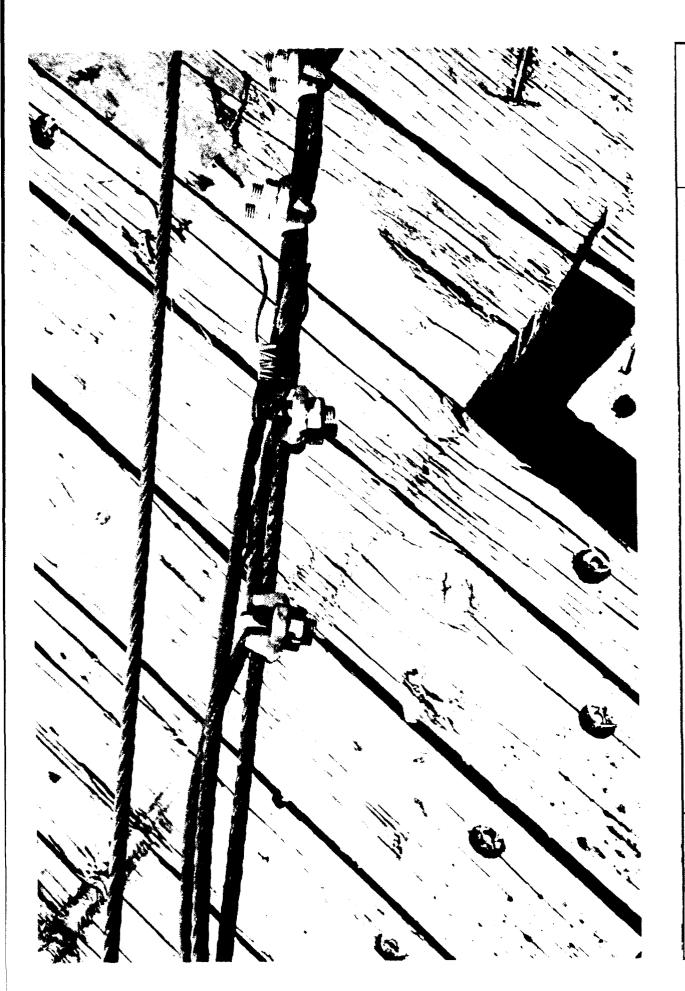
Photo No. A0317-SCN-90-353-5249. This photo shows the method of securing the tiedown cables used during the rotary towed sweeper test. Note the condition of the floor of the flatcar.

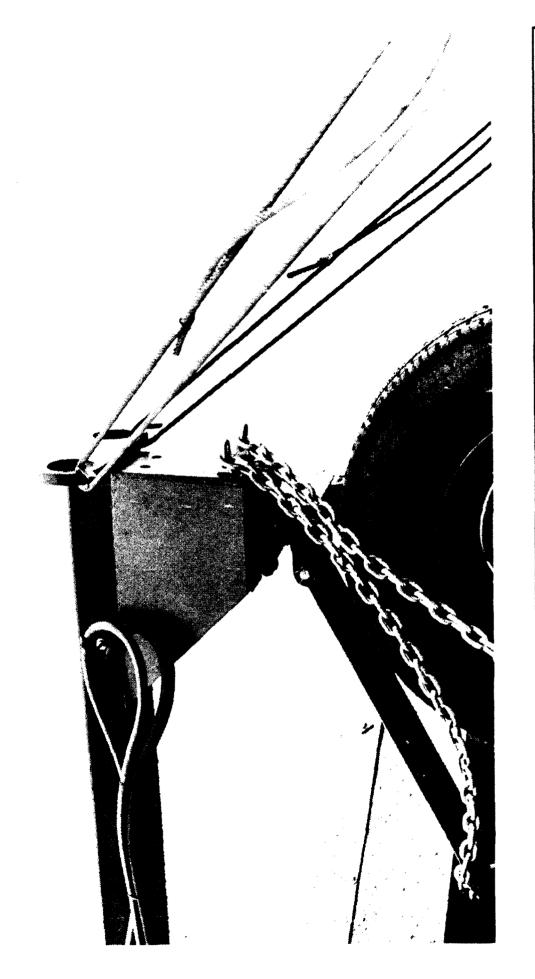
Photo No. A0317-SPN-90-353-5277. This photo shows the rotary towed sweeper's towed end tiedown provision with tiedown cables used to secure it to a flatcar.

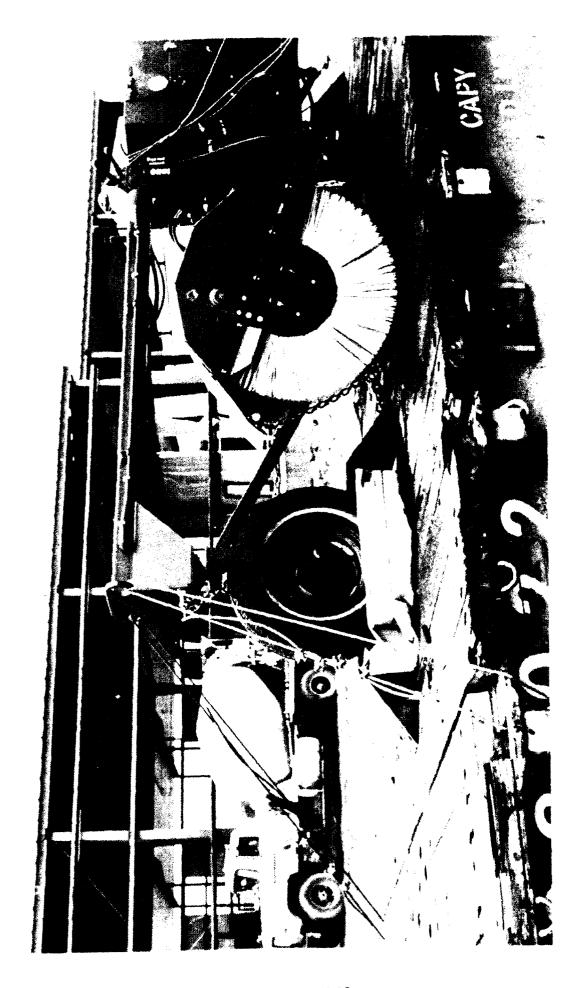
Photo No. A0317-SPN-90-353-5284. This photo shows a tiedown provision on the rear of the rotary towed sweeper with a cable securing it to a flatcar. Note the wheel chocks and side bracing with anti-scuff material.
